## SPECIAL REPORT : SR2000/002

### Dynamic testing of a Yachting Line

**Client :** NSW Police Service  
NSW Water Police Branch,  
Wharf 25  
Harris Street  
PYRMONT NSW 2009.

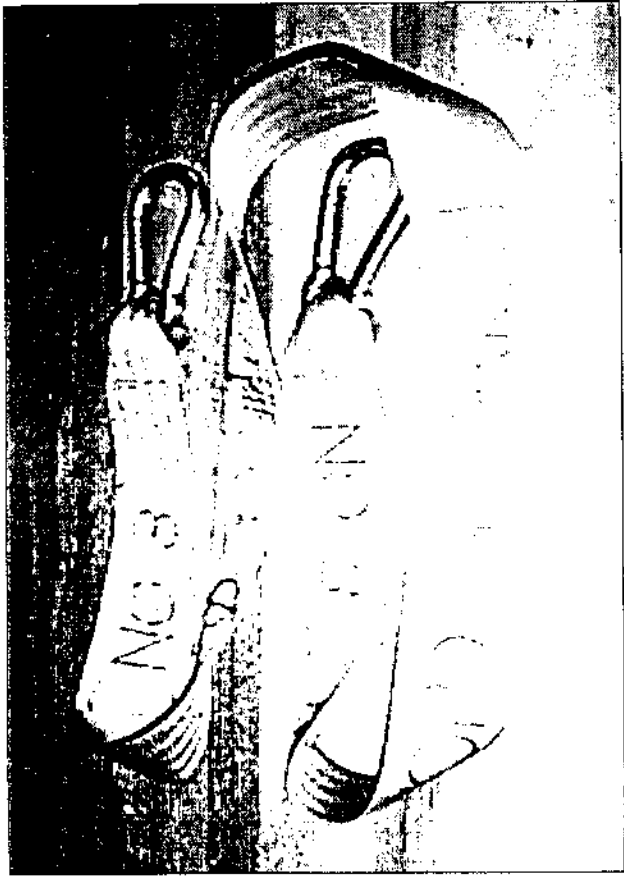
Photograph 1 – Comparison of safety lines,  
TUFF marine yachting line.

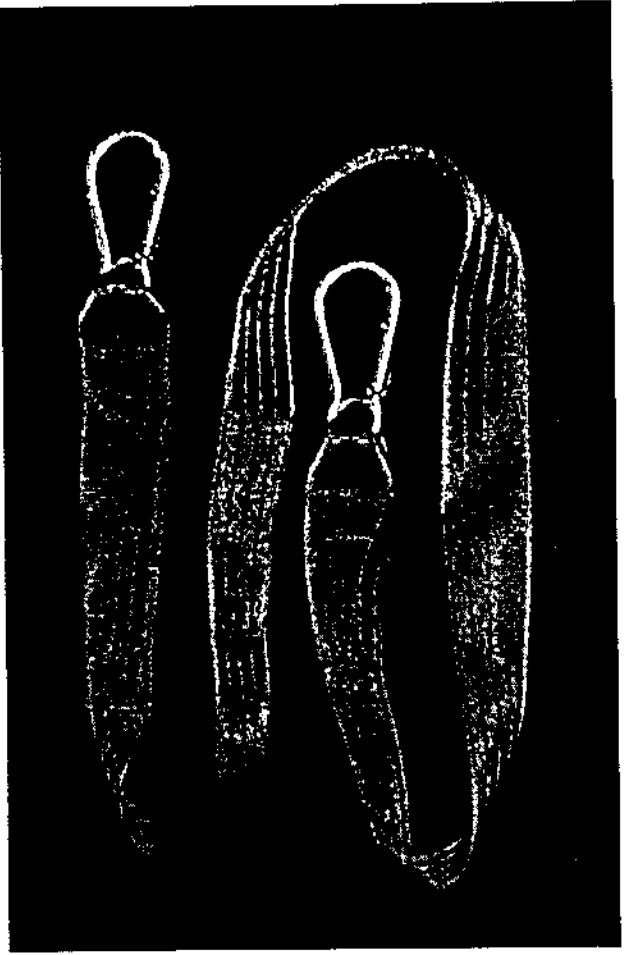
The stitch pattern used on the 'replica' safety line consisted of three stitched 'bar tacks' which were slightly longer than the 'bar tacks' used on the original safety lines from the 'Sword of Orion'. It was expected that the replica safety lines would give slightly higher loads as a result of more thread being used in the three longer stitched 'bar tacks' and the test results confirmed this expectation.

Photograph 2 – Comparison of safety lines,  
replica yachting line.

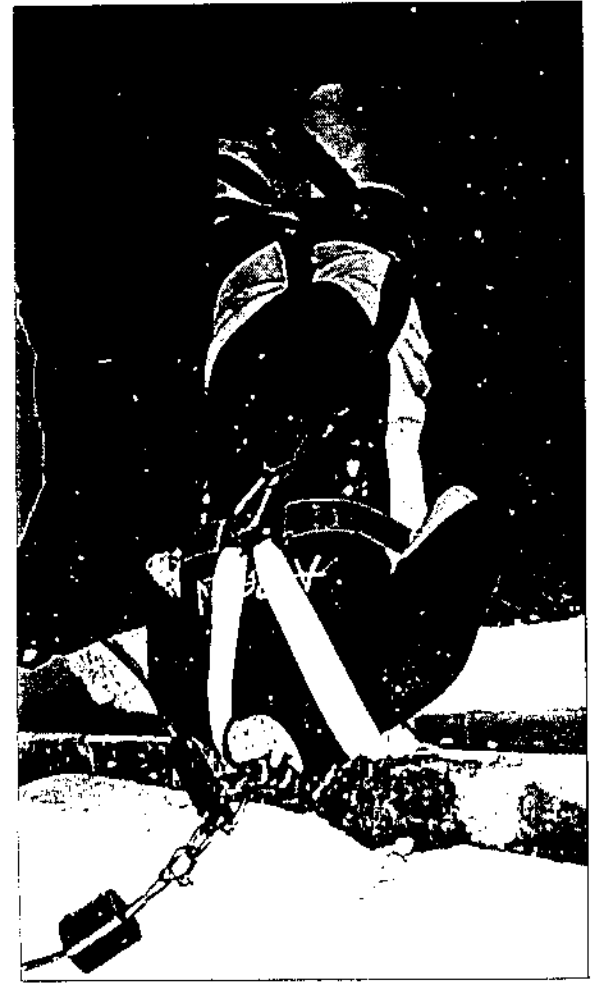
Post test examination of the yachting line revealed that the extent of failure of the stitch pattern at the anchorage attachment end was severe. The anchorage end stitch pattern failed completely at 9.7 kN and the snaphook separated from the line.

The harness attachment end stitch pattern had approximately ten percent of the main stitch pattern torn and approximately fifty percent of one of the small reinforcing stitch patterns torn. The test dummy was not retained and only the hook was left at the anchorage point. Refer to Photographs 3,4, and 5 in Appendix B.

**Assessment: Fail, Clause 7(a) and (b).**

*Photograph 3 – Post test photo of Test Run IH90338.*

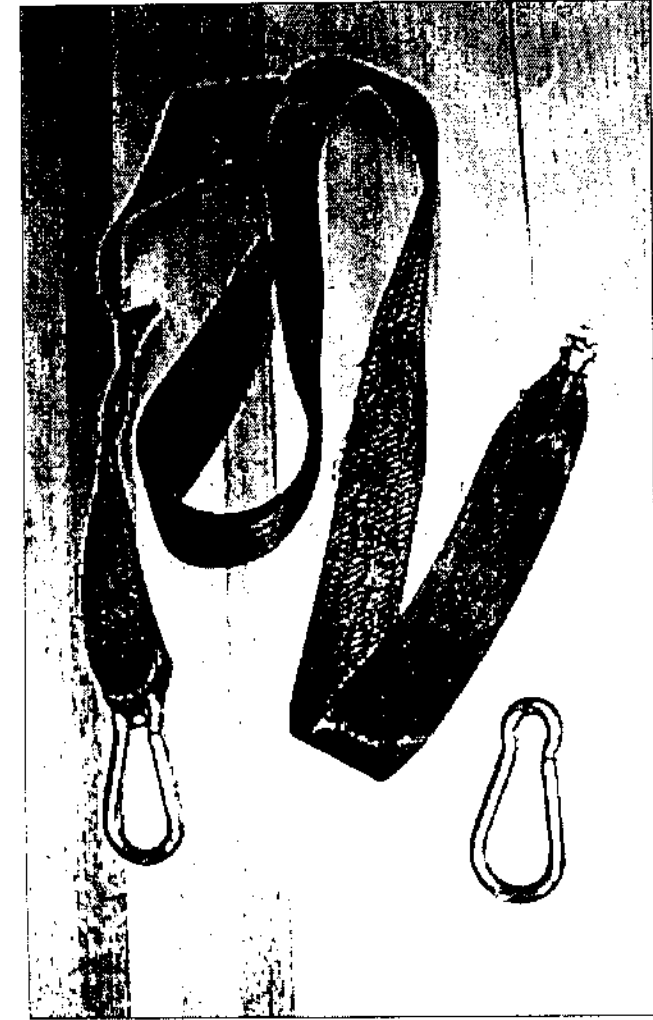
Photograph 5 – Post test photo replica safety line,  
test run number IH90338.

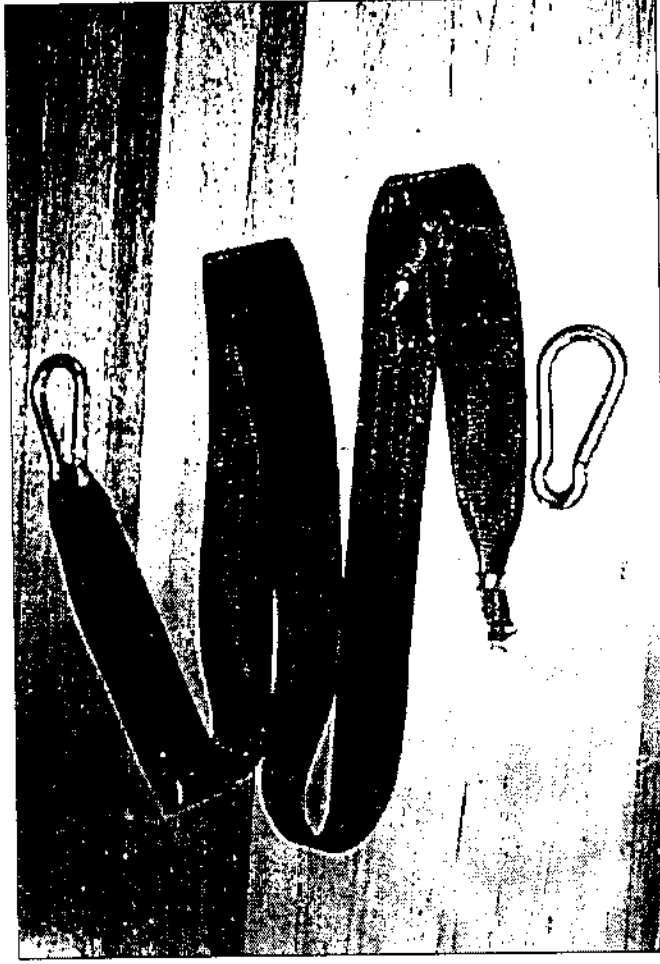
Post test examination of the yachting line revealed that the extent of failure of the stitch pattern at the harness attachment end was severe. The harness end stitch pattern failed completely at 10.5 kN and the snaphook separated from the line.

The anchorage attachment end stitch pattern had approximately fifteen percent of the main stitch pattern torn and approximately seventy-five percent of one of the small reinforcing stitch patterns torn.

The test dummy was not retained and only the hook was left at the harness anchorage point. Refer to Photograph 6 in Appendix B.

**Assessment: Fail, Clause 7(a) and (b).**

Photograph 6 – Post test photo replica safety line,  
test run number IH90339.

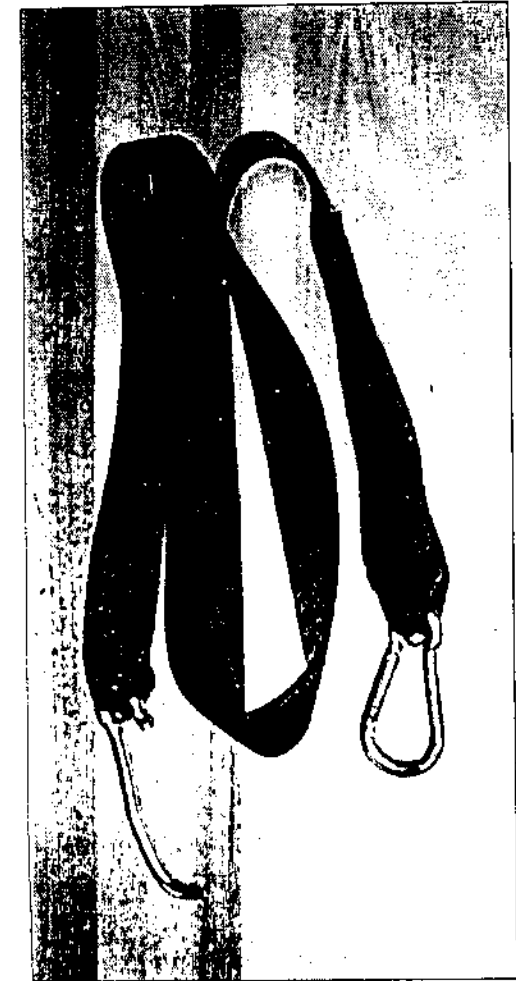
Post test examination of the yachting line revealed only minor stitch pattern failure at the anchorage attachment and harness attachment ends. The anchorage end snaphook failed completely at 9.0 kN.

The test dummy was not retained. Refer to Photograph 7 in Appendix B.

**Assessment: Fail, Clause 7(a) and (b).**

Photograph 7 – Post test photo replica safety line,  
test run number IH90340.

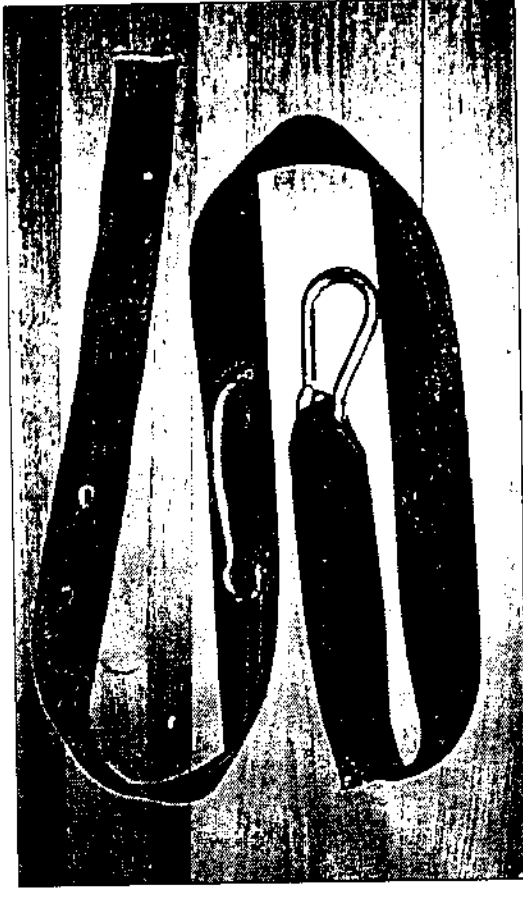
Post test examination of the yachting line revealed that the extent of failure of the stitch pattern at the harness attachment end was severe. The harness end stitch pattern and the snaphook failed completely at 10.8 kN.

The anchorage attachment end stitch pattern had approximately fifteen percent of the main stitch pattern torn and approximately sixty percent of one of the small reinforcing stitch patterns torn.

The test dummy was not retained. Refer to Photograph 8 in Appendix B.

**Assessment: Fail, Clause 7(a) and (b).**

Photograph 8 – Post test photo replica safety line,  
test run number IH90341.
