SPECIAL REPORT : SR99/007

Tensile testing of a Yachting Line

Client : NSW Police Service
NSW Water Police Branch,
Wharf 25
Harris Street
PYRMONT NSW 2009.

Test Items : Two (2) Replica yachting lines.

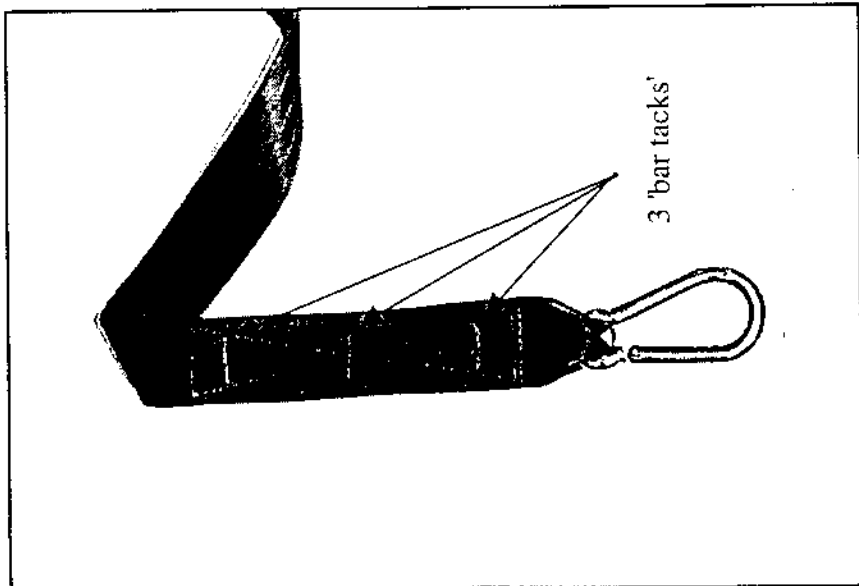
Photograph 3.

The 'replica' yachting line consisted of a length of blue webbing with hooks attached at both ends. The hooks were retained by the webbing being folded through an eye in the hook and then stitched in place. The stitch pattern consisted of three stitched 'bar tacks' and a large rectangular stitch pattern with diagonals. The three stitched 'bar tacks' were slightly longer in length than the 'bar tacks' used on the safety lines from the 'Sword of Orion'. Refer to Photograph 3 in Appendix B.

The stitch pattern used on the 'replica' yachting line consisted of three stitched 'bar tacks' and a large rectangular stitch pattern with diagonals. The three stitched 'bar tacks' were slightly longer than the 'bar tacks' used on the original safety lines from the 'Sword of Orion'. It was expected that the replica safety lines would give slightly higher tensile loads as a result of more thread being used in the three longer stitched 'bar tacks' and the test results confirmed this expectation.

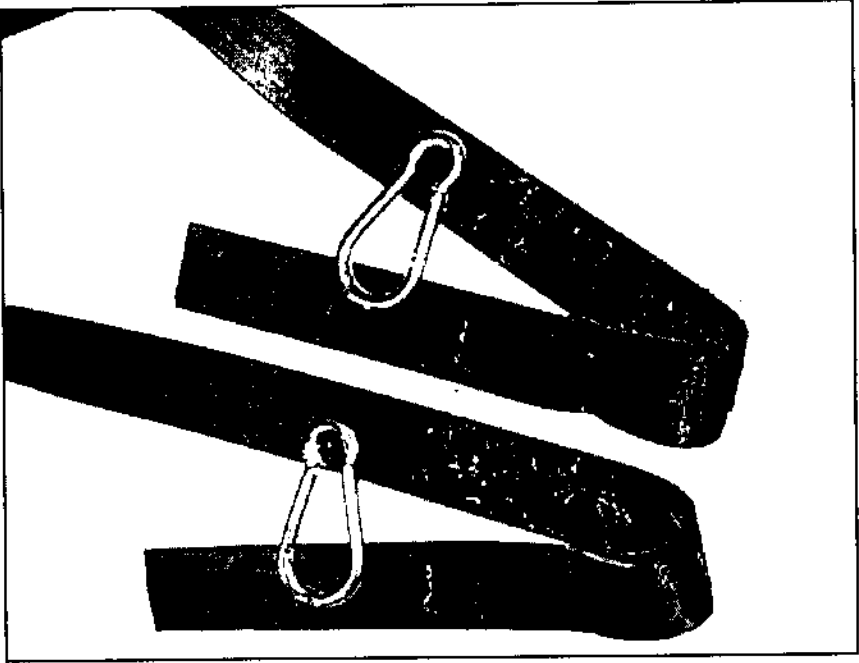
Photograph 4.

This test was conducted with the specimen in the 'dry' condition. A maximum load of 9.85 kN was achieved prior to failure of the stitch pattern.

This test was conducted with the specimen in the 'dry' condition. A maximum load of 9.6 kN was achieved prior to failure of the stitch pattern. It was observed that the load fluctuated as the stitch pattern commenced to fracture and a new portion of the stitch pattern was loaded until complete fracture, this load fluctuation was recorded as being 9.2 - 9.6 kN.

Specimen TS18749 was used in both tests G90099 and G90100. Refer to Photograph 4 in Appendix B.

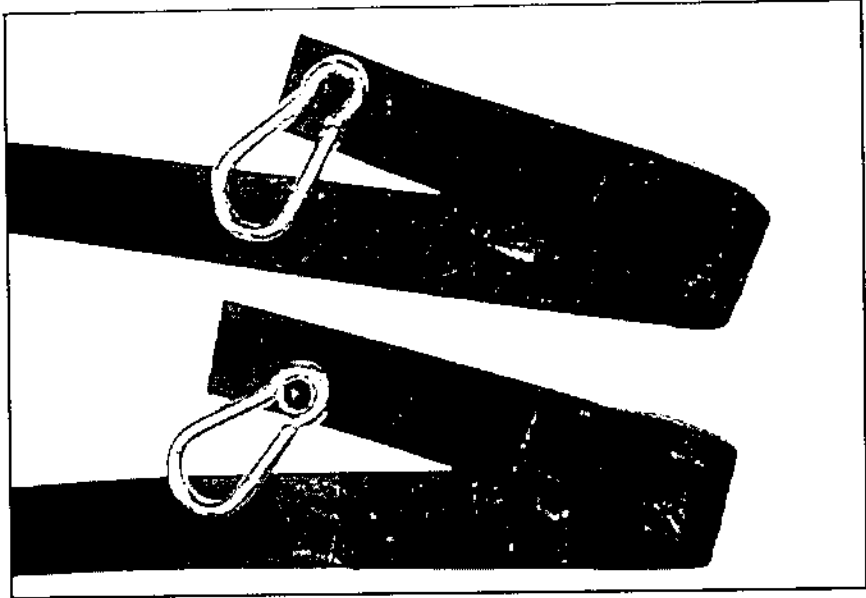
Photograph 5.

This test was conducted with the specimen in the 'wet' condition, the specimen was saturated in a bucket of water prior to testing. A maximum load of 9.0 kN was achieved prior to failure of the stitch pattern.

This test was conducted with the specimen in the 'wet' condition, the specimen was saturated in a bucket of water prior to testing. A maximum load of 8.9 kN was achieved prior to failure of the stitch pattern. It was observed that the load fluctuated as the stitch pattern commenced to fracture and a new portion of the stitch pattern was loaded until complete fracture, this load

fluctuation was recorded as being 7.2 - 8.9 kN.

Specimen TS18750 was used in both tests G90101 and G90102. Refer to Photograph 5 in Appendix B
