DATE: 23/9/99

FROM: John Ferris

SUBJECT: Liferaft research trials, Launceston, for Police report to Coroner
Re 1998 Sydney-Hobart Race.

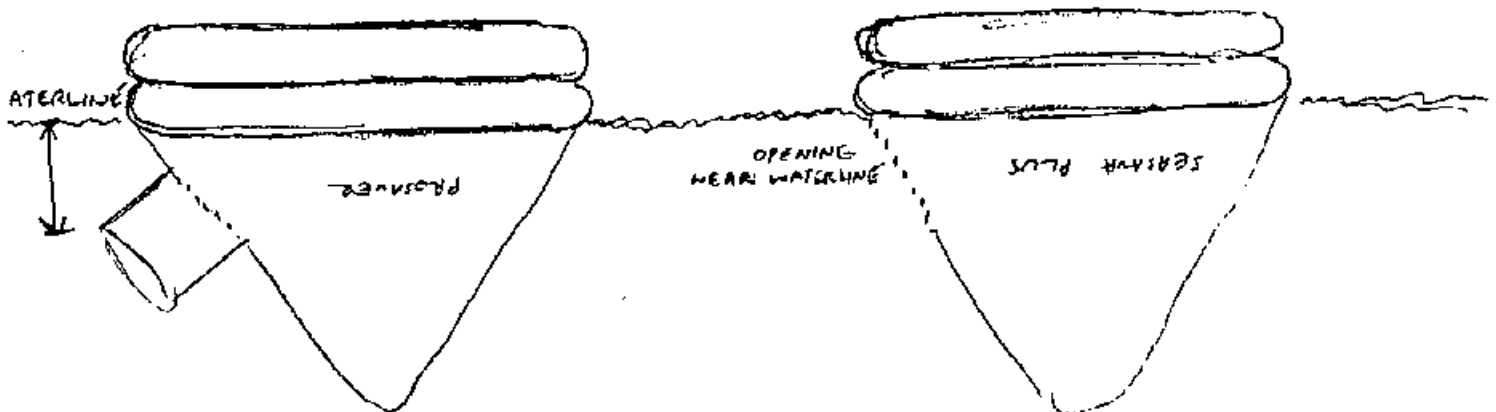
Second - I could see on most egresses how the canopy "door" became a funnel after it was untied from inside. This did not seem to hinder exiting the liferaft to any great degree when only one person was involved although lifejackets caught on the drawstring occasionally. It did restrict new air entering the liferaft from a possible upward push when inverted because the raft could not be lifted high enough for the funnel to break the surface of the water. This is easy with our Seasava Plus and old ME models - I've done it myself. (See diagram).

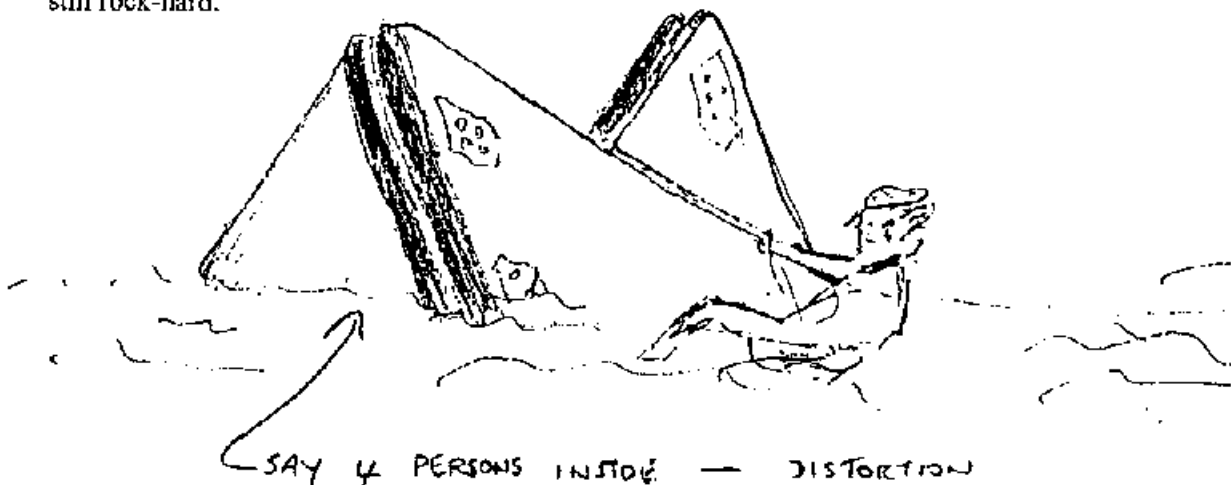
The police divers were then required to wear wet weather gear and Coastal lifejackets and several trials at boarding the PROSAVER right-way-up and upside down were carried out. Exhaustive righting trials were carried out to determine the ability or otherwise of righting the raft with one, two, three, four and even five people inside. This became more and more difficult as more people were inside and the diagonal righting strap's natural tendency to want to pull from one top corner and rotate the raft in the process was the main problem. Finally, the strap pulled away from its top securing position tearing the doubler as it came. Interestingly, the whole doubler patch did not come away from the buoyancy – only about a quarter of it! This says something for the original gluing.

I was astounded how well the product stood up to the treatment. At times the righting strap (or cord in the modified version) was distorting the buoyancy so much I was sure it would cut right through. I don't think anyone present with any knowledge of liferaft construction would have been critical of the tearing of the two attachment patches – it was inevitable under the stresses and strains being exerted. I doubt that any other brand or type of liferaft would have performed much differently. At the conclusion of the day all buoyancy was still rock-hard.

With the help of an AMC staff member (John Frearson) we repaired the damage as best we could so that sea trials could be conducted next day.
