SPECIAL REPORT : SR99/007

Tensile testing of a Yachting Line

Client : NSW Police Service
NSW Water Police Branch,
Wharf 25
Harris Street
PYRMONT NSW 2009.

Test Items : Two (2) Replica yachting lines.

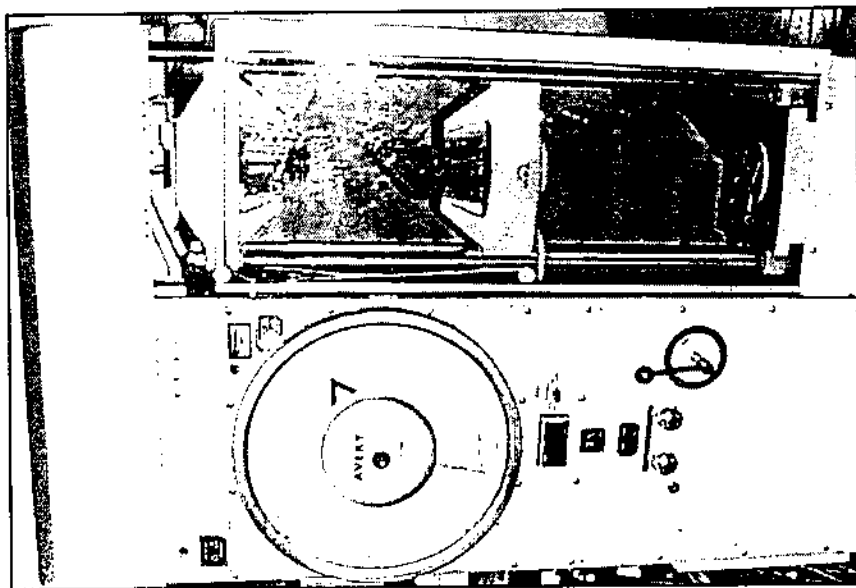
Photograph 1.

Testing was conducted on an Avery Tensile Tester, Type No. 7108 DCN, Machine No. E70421, identified by Crashlab equipment number of TCL 474. Refer to Photograph 1 in Appendix B.

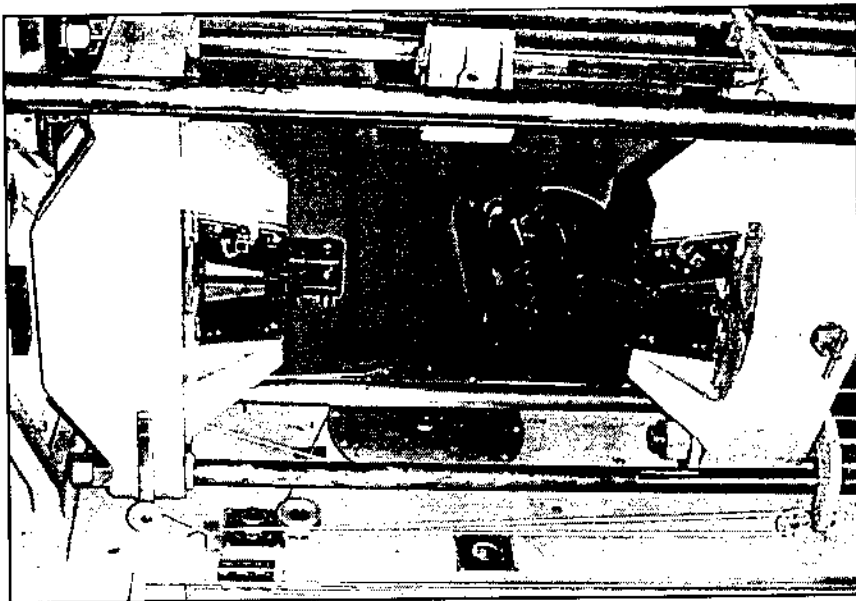
Photograph 2.

Bollards were used to grip the webbing and prevent slippage and damage of the test specimen as per Australian Standard AS E35/BWG. Refer to Photograph 2 in Appendix B.

The hook from end '5B' was attached to a fixture at the top head of the Avery and the webbing end was threaded through the Bollard grips at the bottom head. Refer to Photograph 2 in Appendix B.

The hook from end '5A' was attached to a fixture at the top head of the Avery and the webbing end was threaded through the Bollard grips at the bottom head. Refer to Photograph 2 in Appendix B.

The hook from end '6B' was attached to a fixture at the top head of the Avery and the webbing end was threaded through the Bollard grips at the bottom head. Refer to Photograph 2 in Appendix B.

The hook from end '6A' was attached to a fixture at the top head of the Avery and the webbing end was threaded through the Bollard grips at the bottom head. Refer to Photograph 2 in Appendix B.
